Indicative fire test of
utilising the heating and
pressure conditions given
in BS EN 1363-1:2012

WF Report No:
375988 Issue 3

Frelan Hardware.
Unit 10 Mitcham Ind Est
Streatham Road
Mitcham
Surrey
CR4 2AP

The purpose of the test was to provide an indication of the fire resistance performance of Frelan Hardware 5-levere sashlock referenced JL136 when installed in to 30 and 60 minute fire rated simulated single-acting single-leaf doorsets.

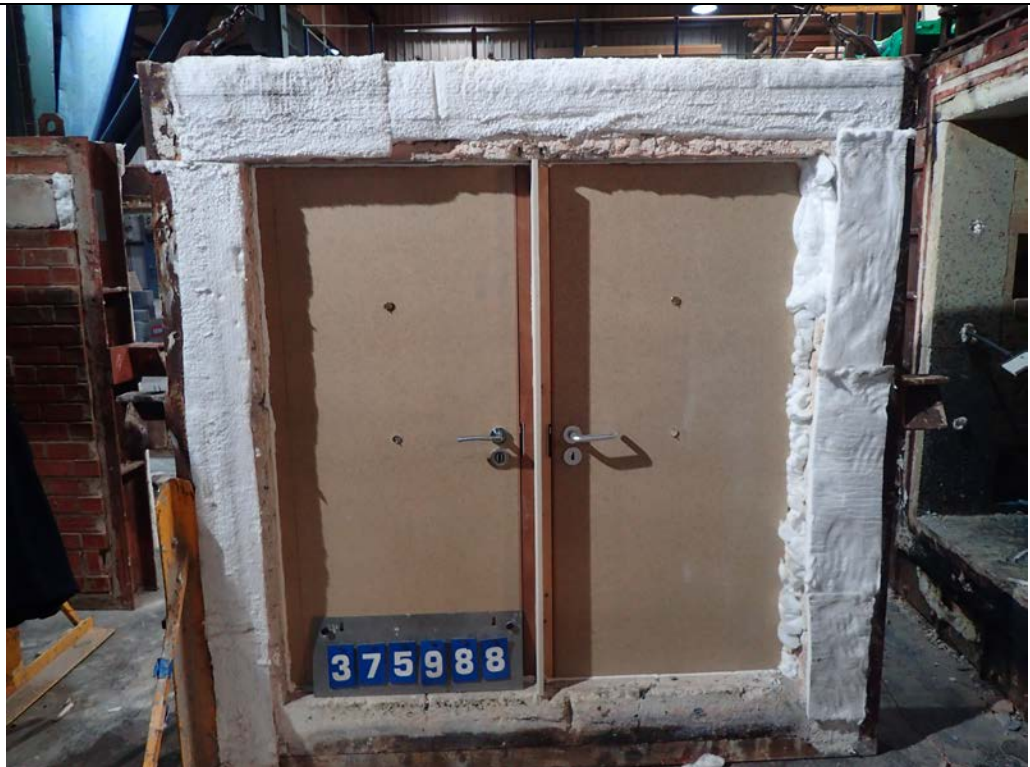
The exposed face of the specimens prior to the start of the test

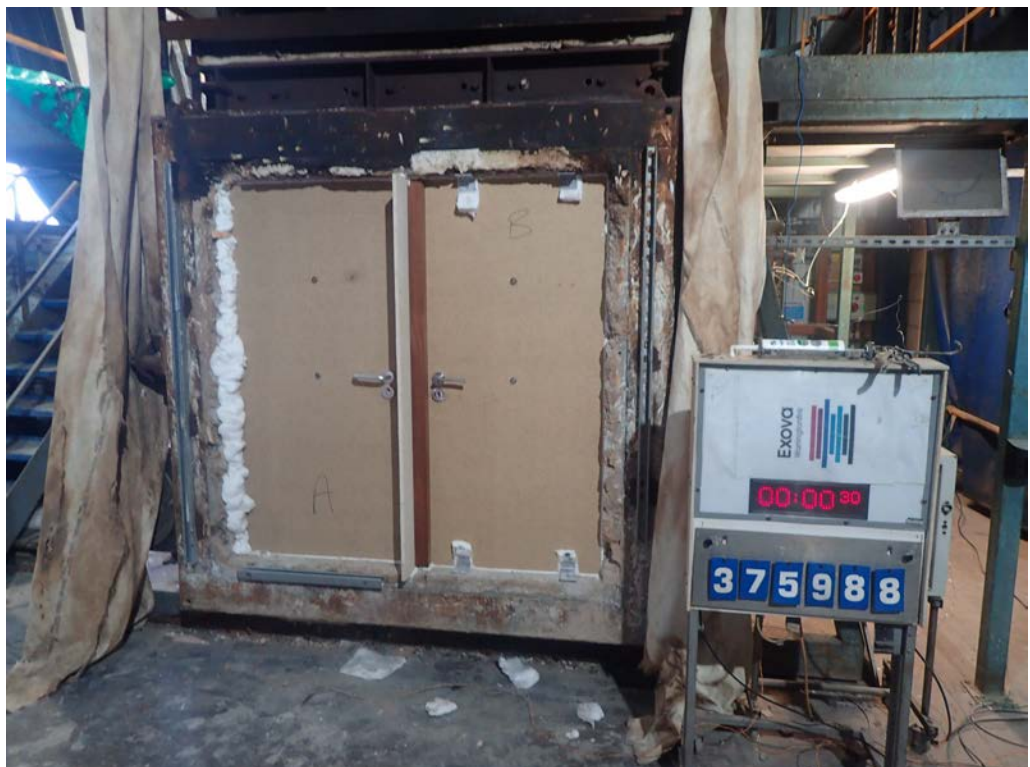
The unexposed face of the specimen prior to the start of the test

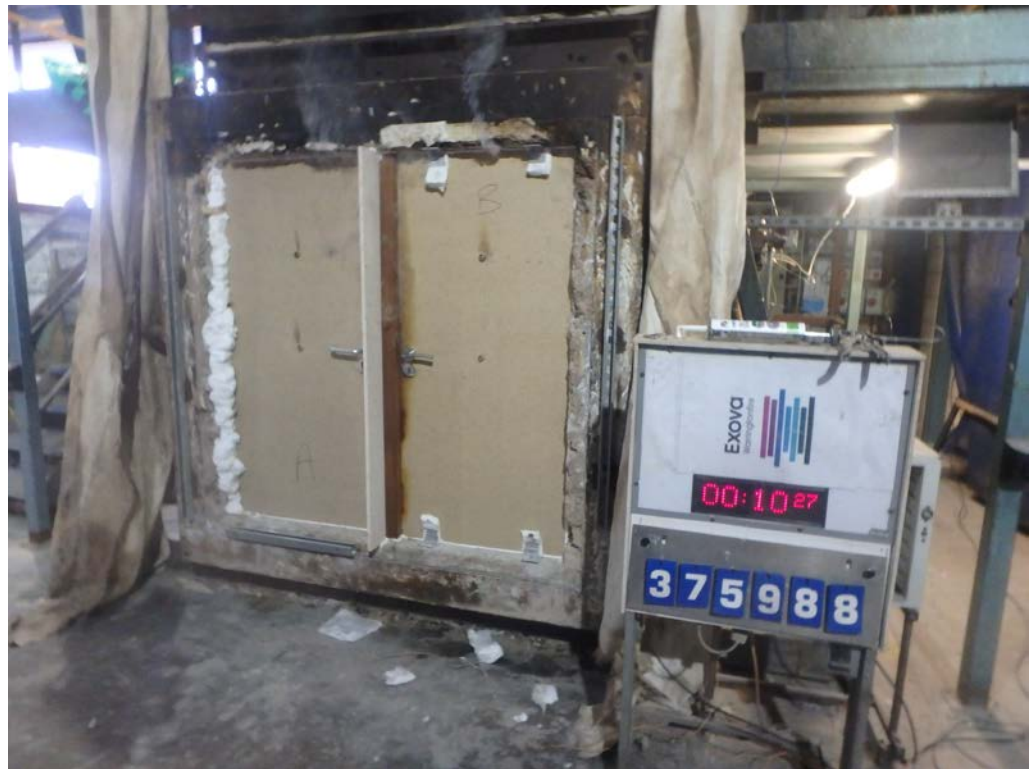
The unexposed face of the specimens after 10 minutes of testing

Time		All observations are from the unexposed face unless noted otherwise.
mins	secs	
00	00	The test commences.
05	00	Steam/smoke release is observed along leading edge of both specimens.
10	00	Heavy steam/smoke release is observed from around the lockset position on both specimens.
22	00	Dark coloured rings are observed forming around the door viewers on both specimens.
34	00	A tiny intermittent flicker of flame is observed next to the lockset on specimen A.
36	00	Specimen A is blanked off to allow the test to continue on specimen B, after showing no signs of integrity failure.
45	00	Dark coloured rings around the door viewers on specimen B expand in size.
48	00	An intermittent flicker of flame is observed from around the outside of the bottom door viewer on specimen B. Cotton wool pad integrity test is performed over the door viewer, the pad didn't ignite.
52	00	The intermittent flicker of flame observed around the outside of the bottom door viewer continues. Cotton wool pad integrity test is performed over the door viewer, the pad didn't ignite.

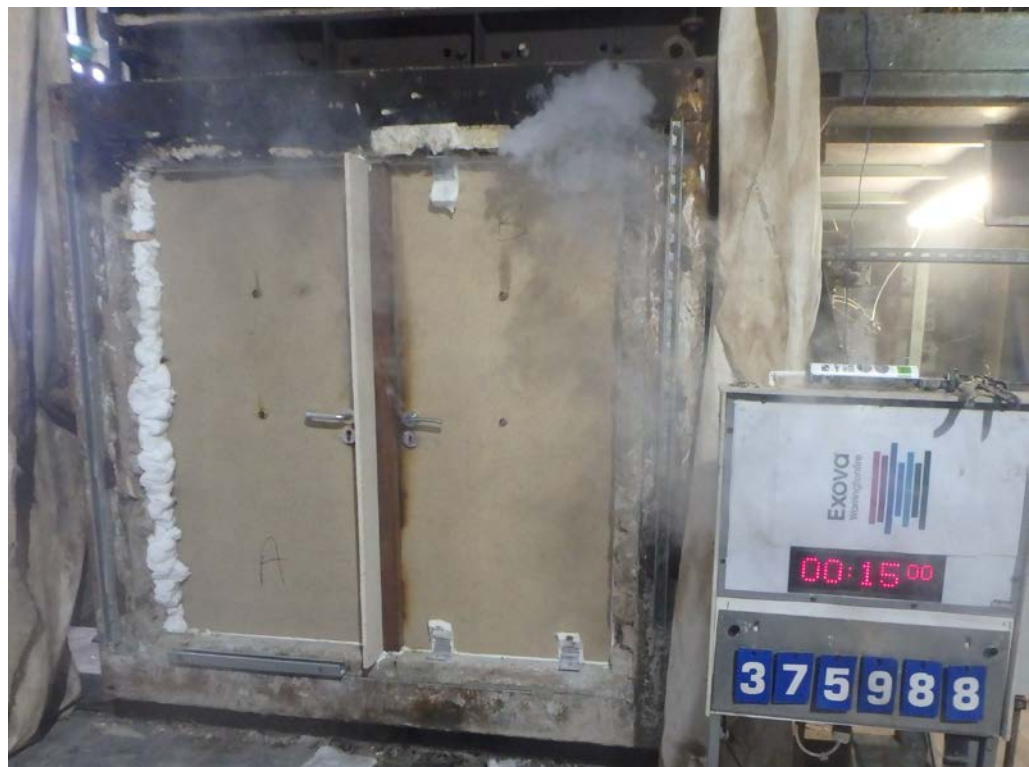
The unexposed face of the specimens after 15 minutes of testing

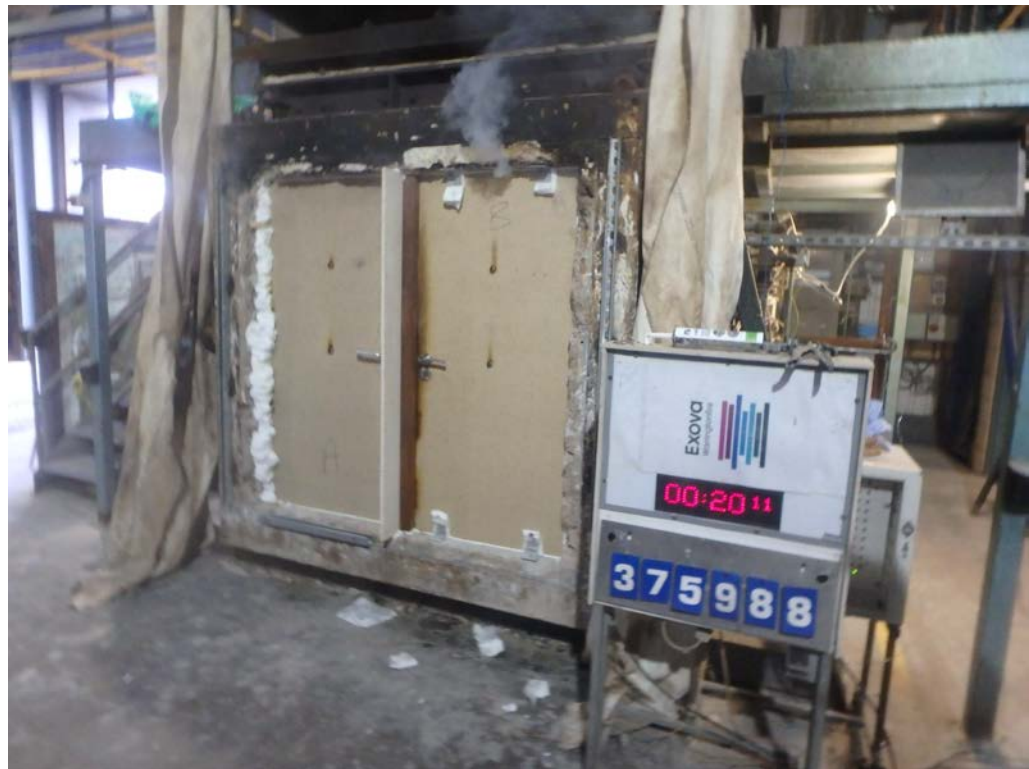
The unexposed
face of the
specimens after
20 minutes of
testing

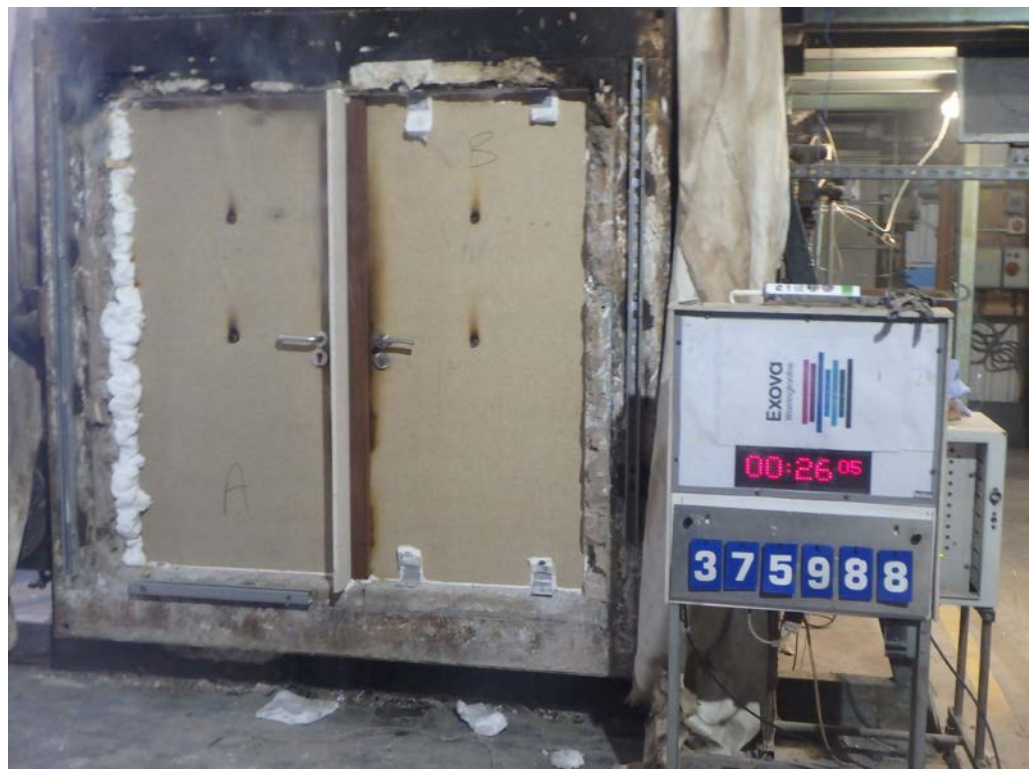
The unexposed
face of the
specimens after
26 minutes of
testing

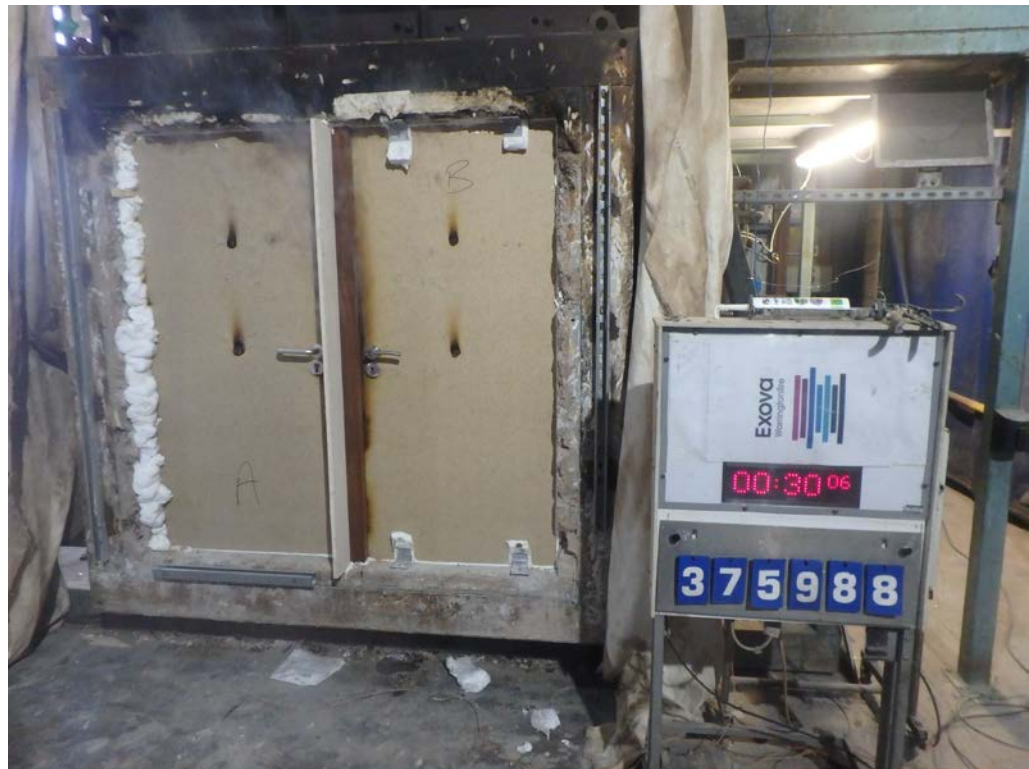
The unexposed
face of the
specimens after
30 minutes of
testing

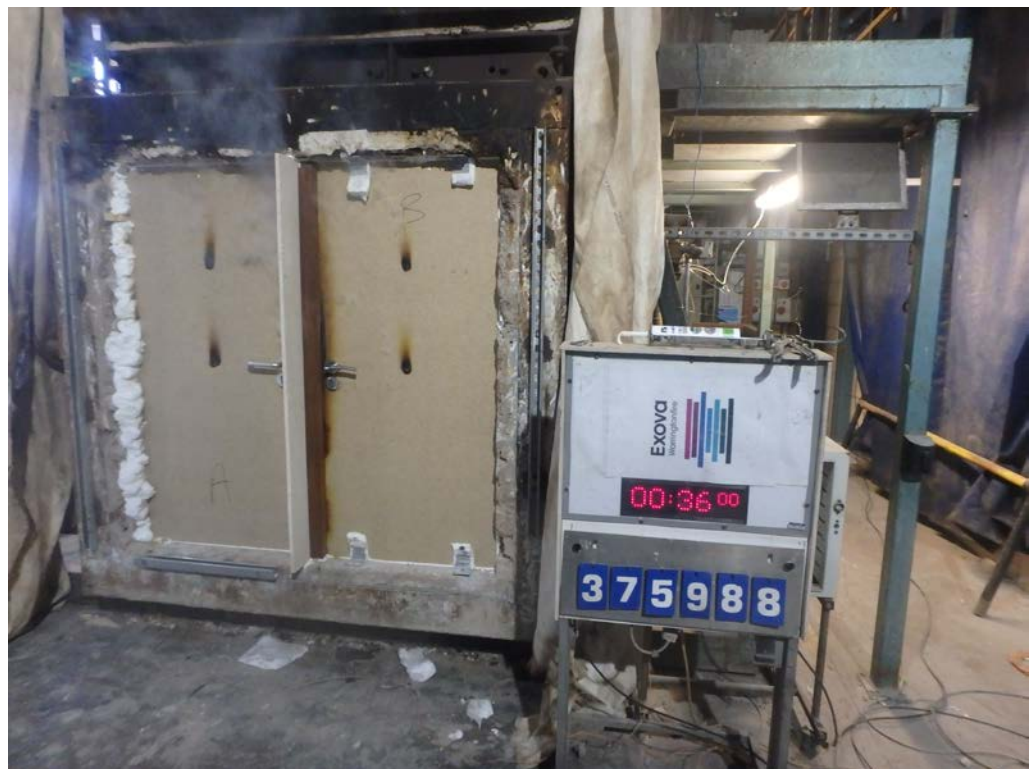
The unexposed
face of the
specimens after
36 minutes of
testing

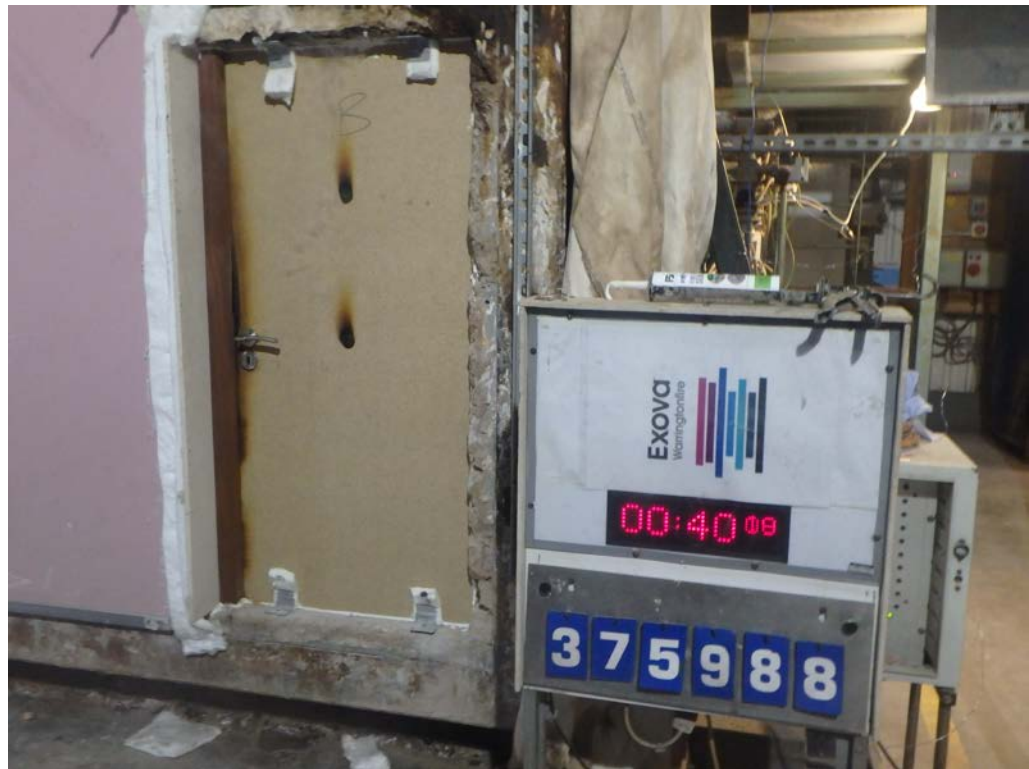
The unexposed
face of specimen
B after 40 minutes
of testing

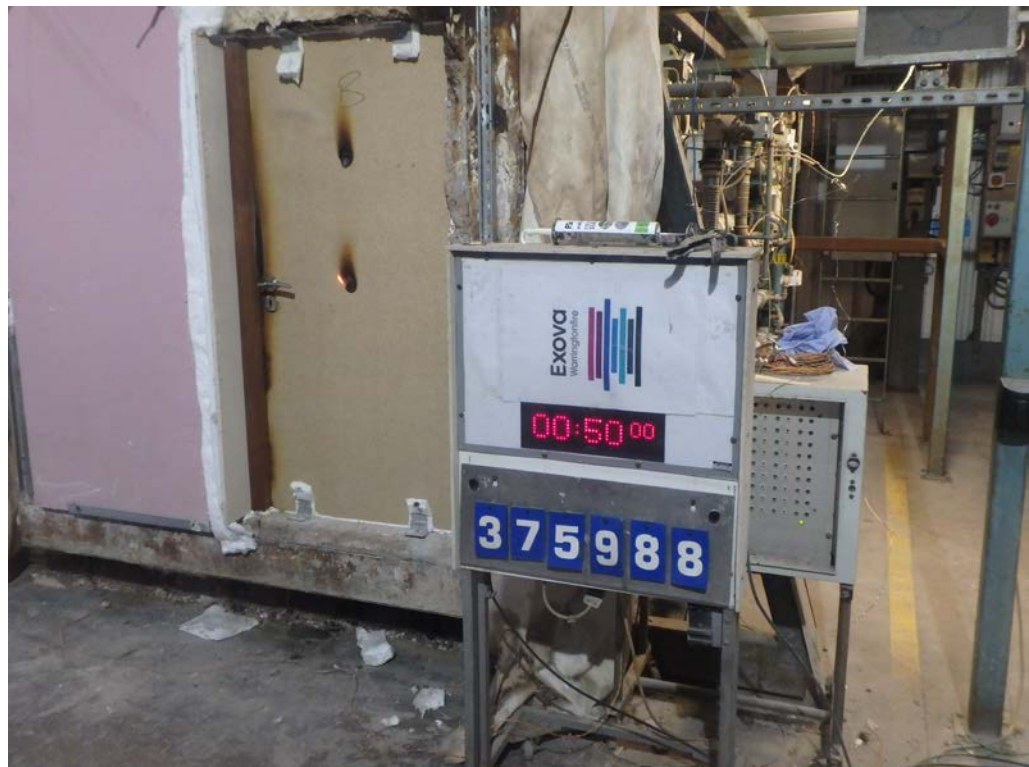
Intermittent flicker
of flame the
unexposed face of
specimen B after
50 minutes of
testing

54	00	The intermittent flicker of flame observed around the outside of the bottom door viewer on specimen B continues. Cotton wool pad integrity test is performed over the door viewer, the pad didn't ignite.
55	00	The intermittent flicker of flame observed around the outside of the bottom door viewer on specimen B continues. Cotton wool pad integrity test is performed over the door viewer, the pad ignites.
57	00	Sustained flaming has formed long the leading edge between the lockset and the frame.
60	00	The test discontinued.

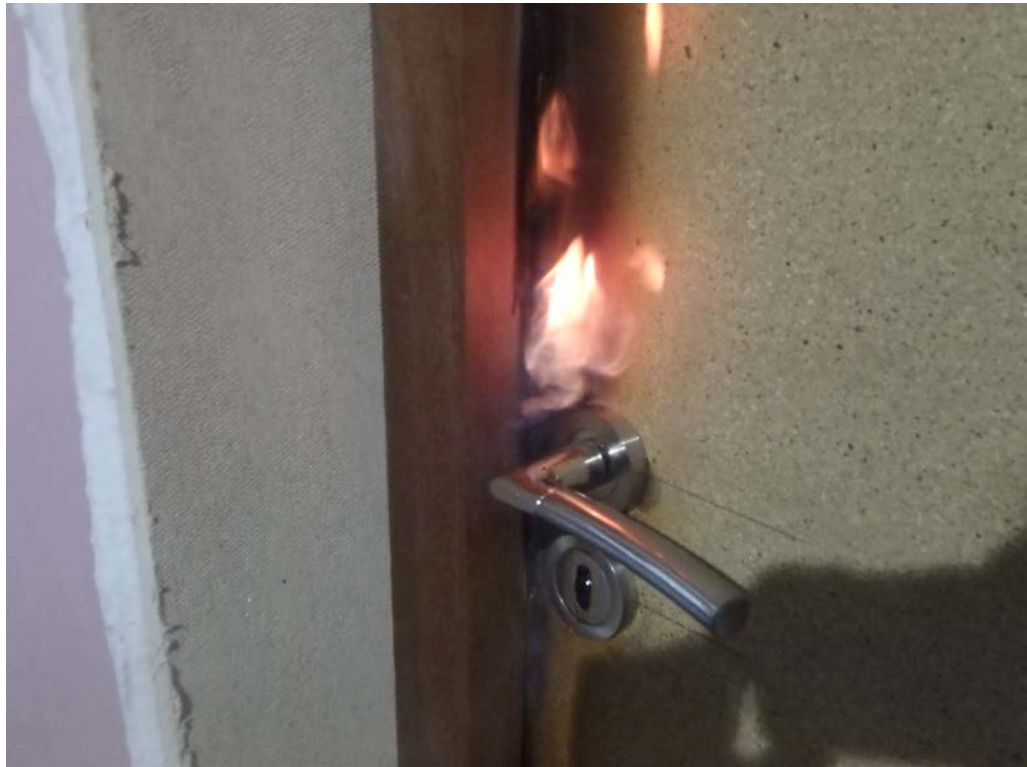
**Sustained flaming
between the frame
and the leaf on the
unexposed face of
specimen B after
57 minutes of
testing**

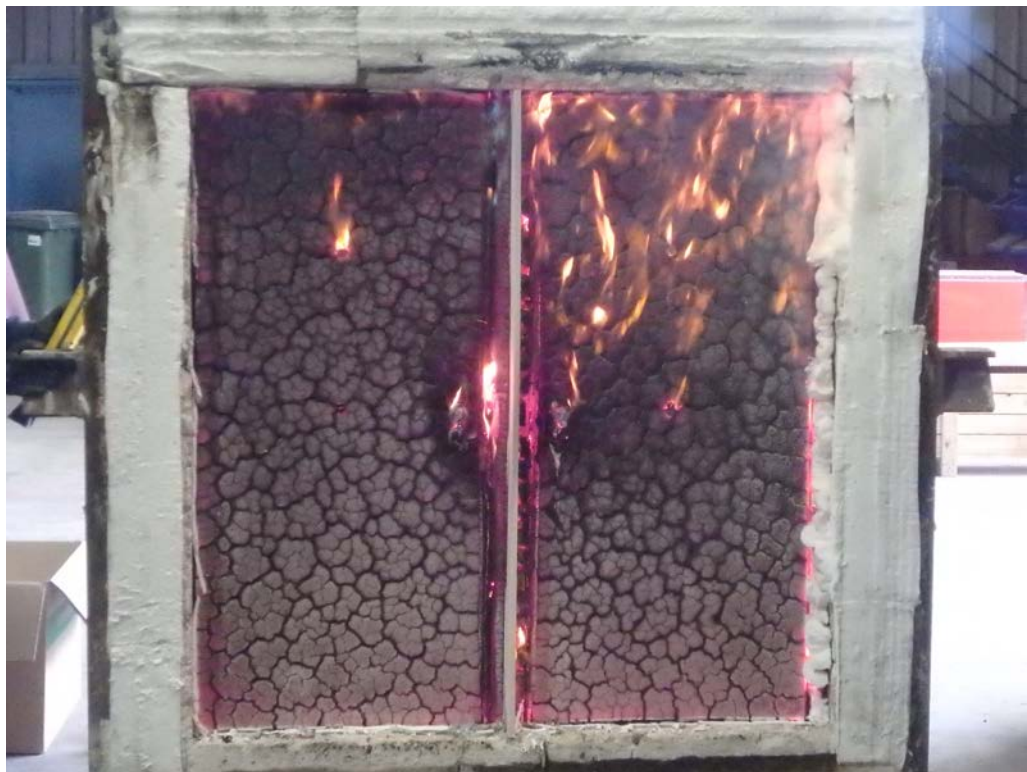
**The exposed face
of the specimens
immediately after
testing**

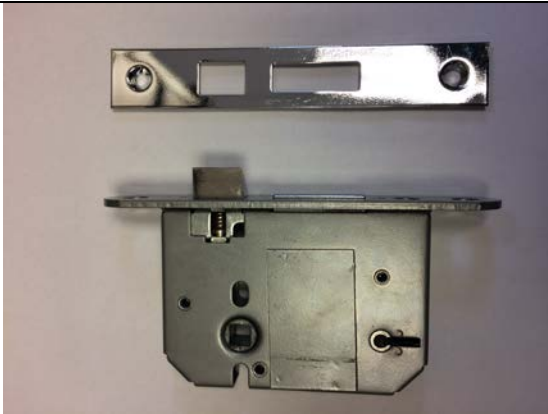
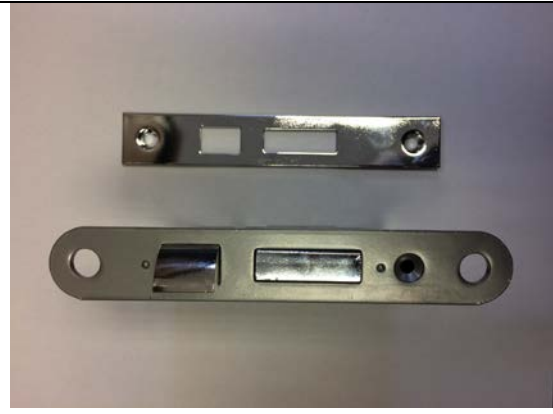
Item 6

Figure 9 – Photos of ironmongery

6. Latch to Doorset	
Manufacturer	: Frelan Hardware
Reference	: JL-BSS76
Material	
i. Lock case	: Steel
ii. Forend plate	: Steel
iii. Latch bolt	: Steel
iv. Lock bolt	: Steel

v. Lock keep	: Steel
Overall sizes	
i. Lock case	: 109.5 mm long x 81 mm wide x 16 mm deep
ii. Forend plate	: 162 mm long x 25.5 mm wide x 3 mm deep
iii. Latch bolt	: 14.5 mm x 20 mm with 12 mm single throw
iv. Lock bolt	: 11.8 mm x 37 mm with 21.5 mm single throw

v. Lock keep	: 178 mm long x 44 mm wide x 23.5 mm deep
Fixing Method	: Steel countersunk wood head screws 28 mm long x 4.7 mm diameter
Intumescent protection

i. Doorset A	: One layer of 1 mm interdens fitted around the lock case and behind the forend, and lock keep
ii. Doorset B	: Two layers of 1 mm interdens fitted around the lock case and behind the forend, and lock keep
Operation of latch bolt	: Engaged
Operation of lock bolt	: Disengaged
