Efectis Nederland report

2008-Efectis-R0463

Determination of the fire resistance according to
EN 1634-1: 2000 of two door-/frame constructions
with the purpose to test the functioning of the
intumescent components of Environmental Seals

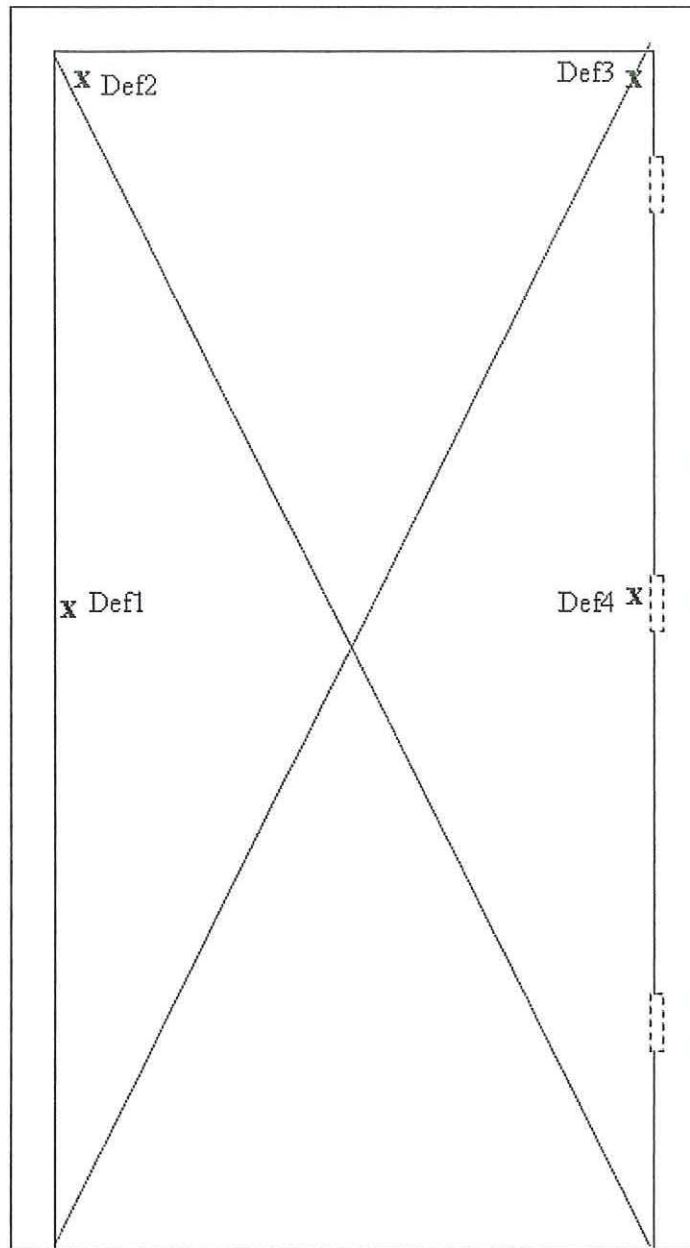
Figure C1c: Positions of deforming measurements

Figure C1c: Positions of deforming measurements

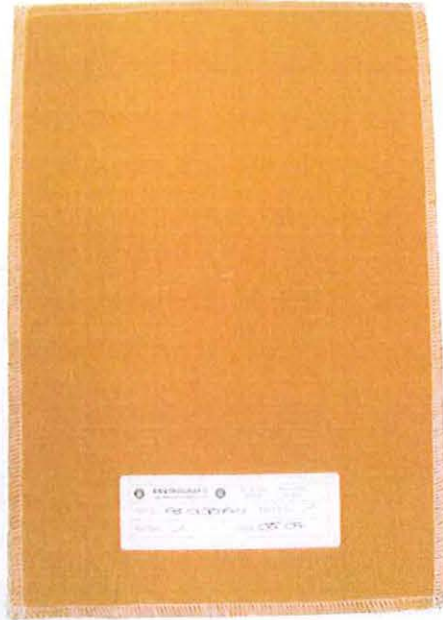
Photo 1: Curtain fabric

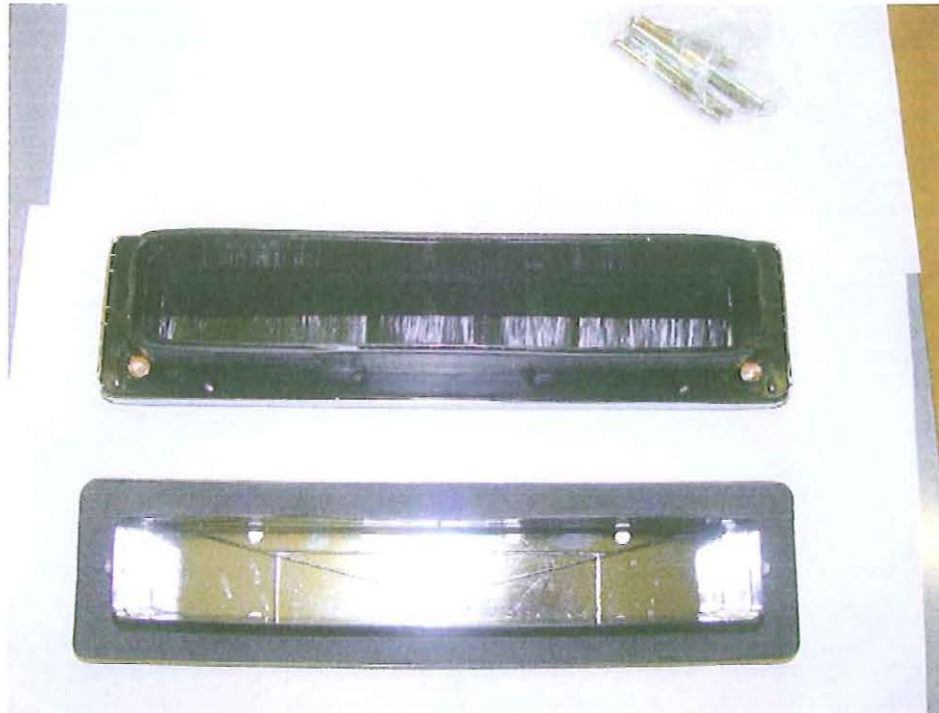
Photo 3: Letterbox with screws

A solid metal letterbox was provided. The bright chrome finished letterbox case was in the middle encased with one layer of intumescent material, product 49 with a thickness of 3 mm. The letterbox was fixed with two screws with dimensions M5 x 45 mm. The letterbox was also provided with a brush behind the lid (see photo 3).

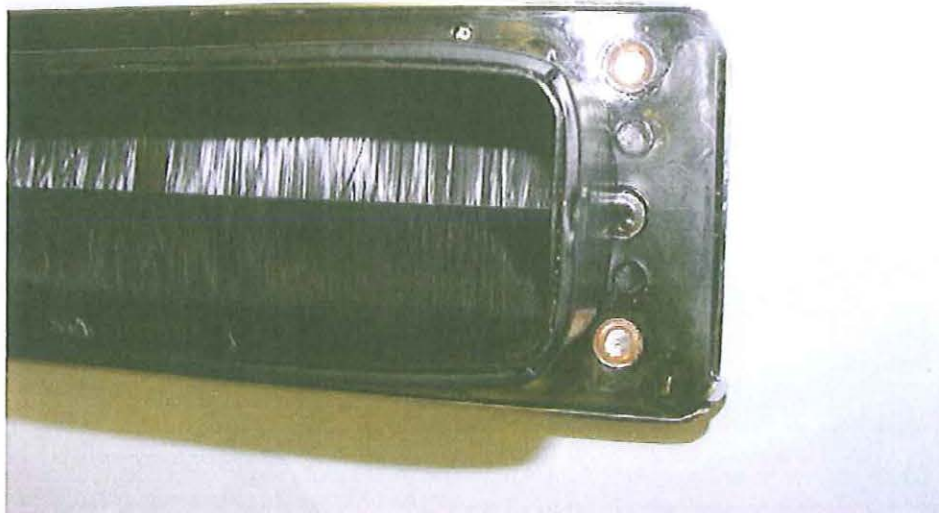
Photo 4: Detail of brush and intumescent material around synthetic middle section

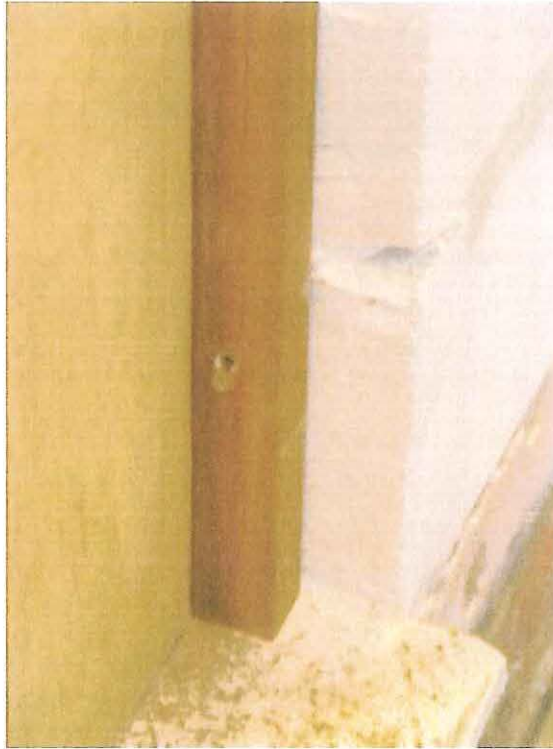
Photo 7: Fixing of wooden door frame

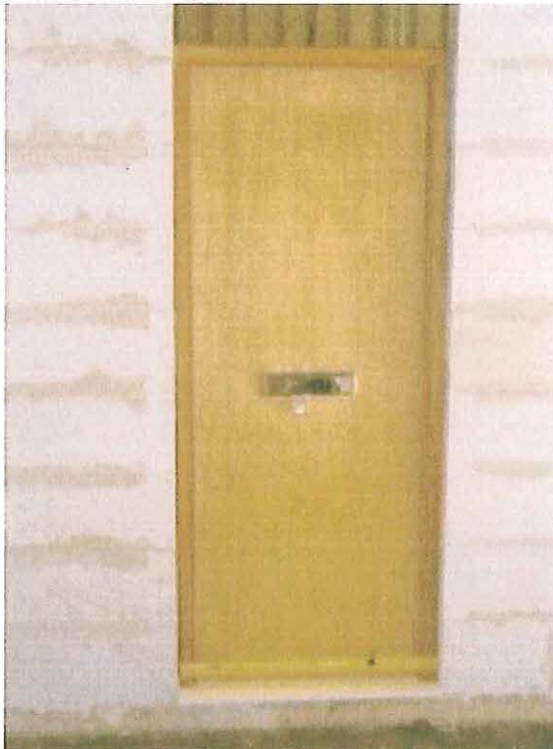
Photo 8: Door A with letterbox during assembly

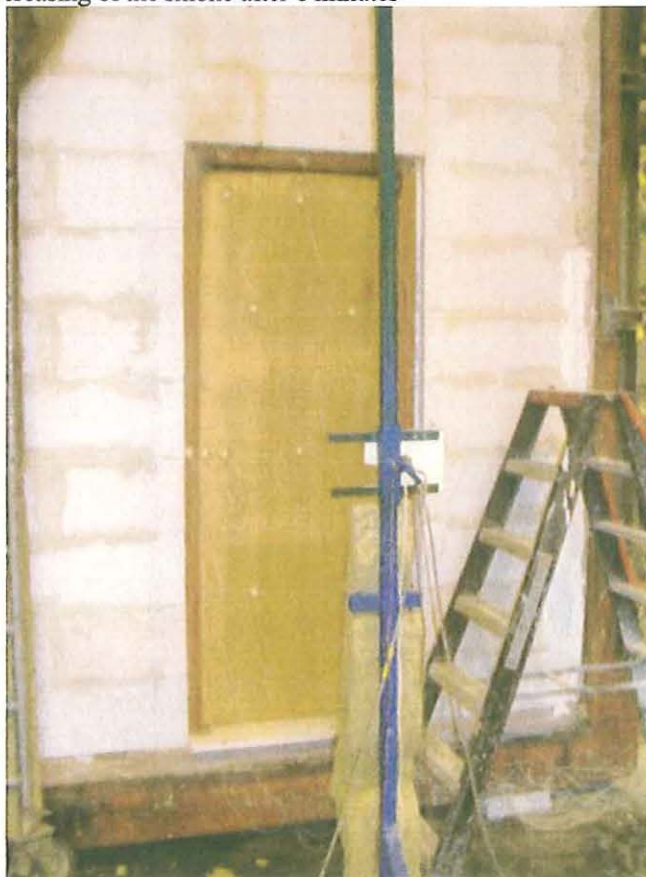
Photo 12: Door A covered with insulation and continued with door B

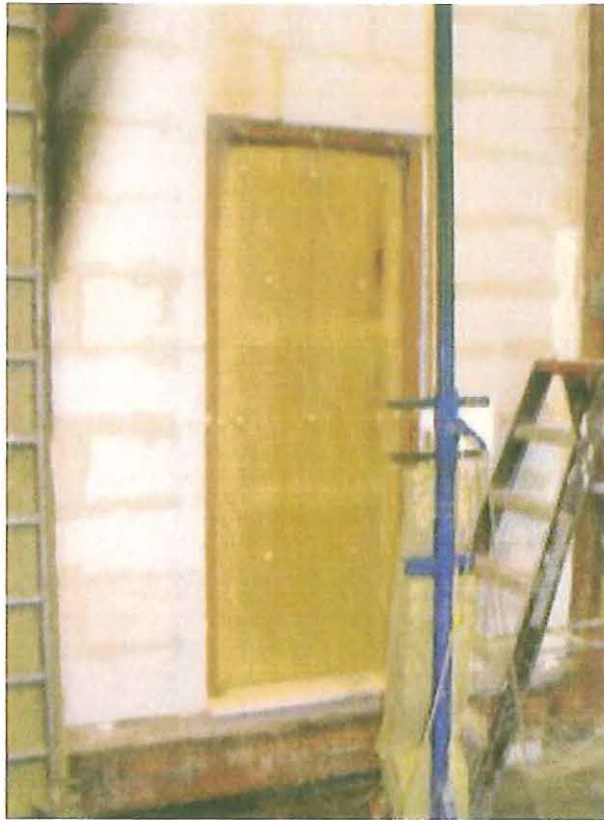
Photo 13: Pattern of insulation panels visible in door surface

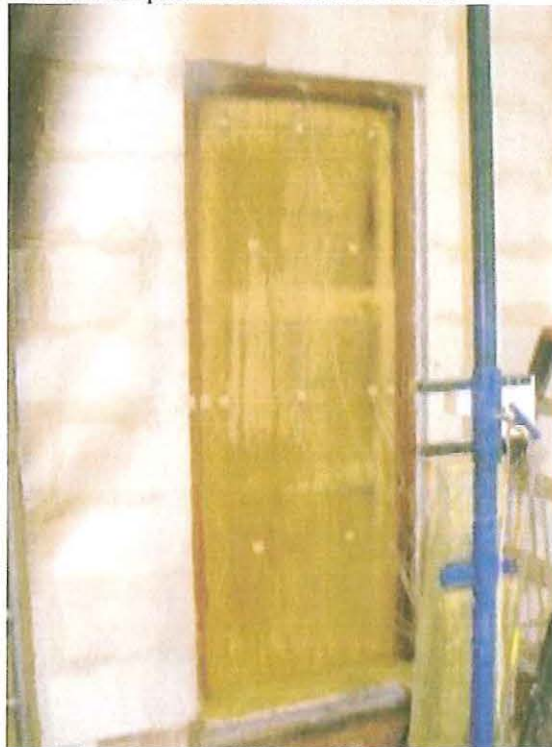
Photo 14: Door at end of the test
